#### **Early Warning Systems** in Switzerland

#### **Discussion of Case Examples**

# Example 1: Ritigraben

# Example 2: Chamoson

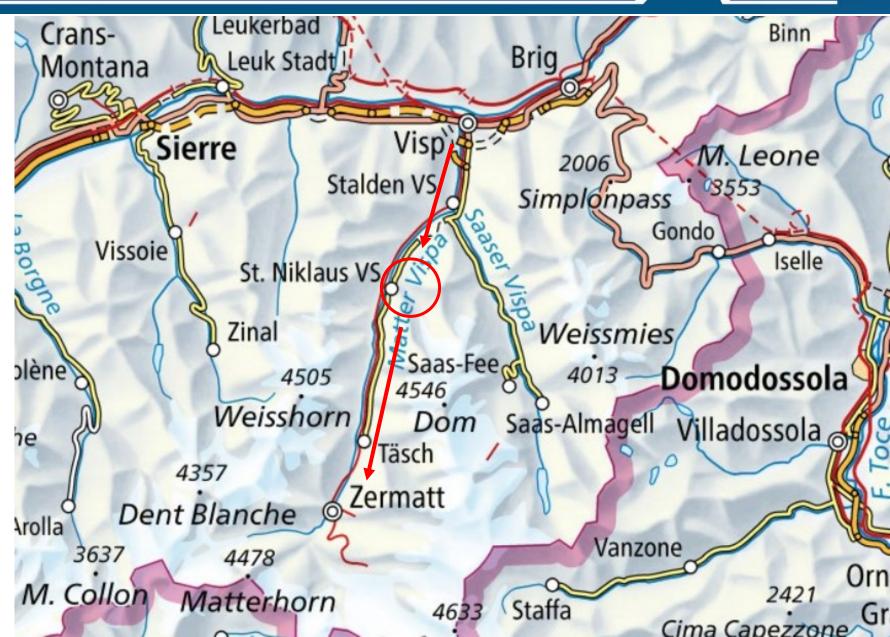
# Example 1: Ritigraben

- Only access road / railway to Zermatt
- High touristic and economic importance
- Debris flow starts in periglacial area (2600) and reaches the road in the valley bottom (1070)
- Alarm system installed in 1995: 29 years of operation

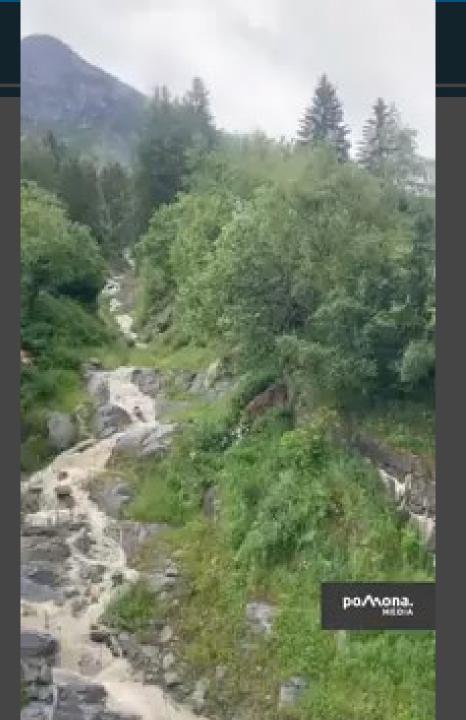
## Example 1 – upper detection

- Relatively slow process (2-4 m/s)
- Upper detection from 1995
- 3 km from road (lower bridge)
- Alarm 15 min ahead is too long
- Small events do not reach the road
- Events may start below
- → detection further down is preferable

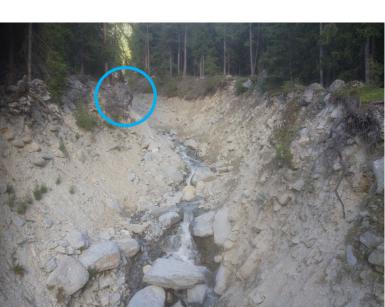
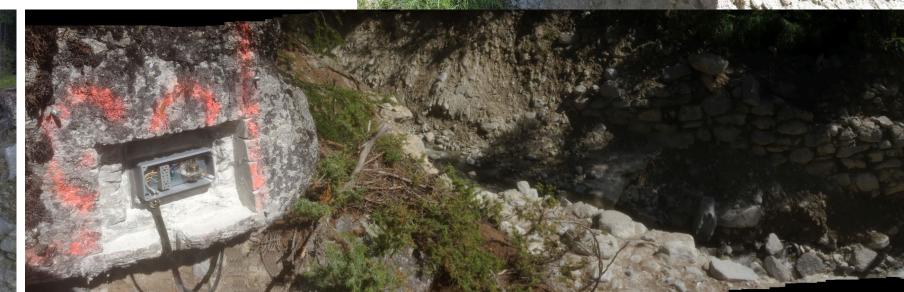
- Middle detection built in 2019
- Level sensor and geophones
- Better alarm quality (event size and shorter lead time)
- Upper station only used for pre-warning

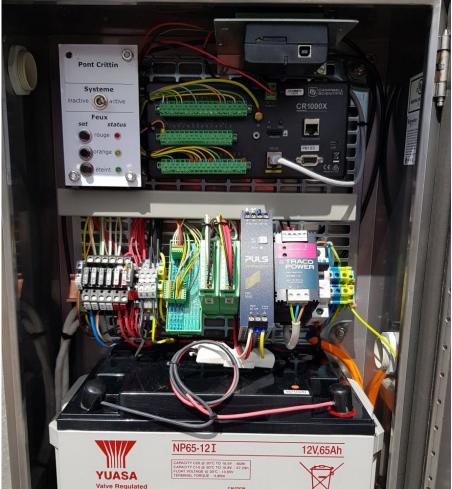
#### Example 2 – System monitoring of signal stations

- cables to traffic lights monitored
- connection test every10 min
- short interruptions of mobile connection
- accepted risk of partial failure

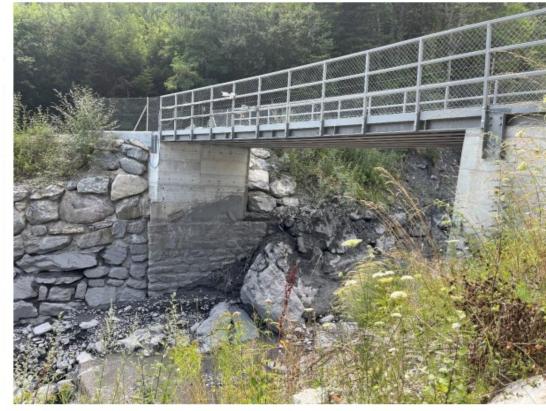
- Debris flow events occurred but were missed by the level radar
- Signals on orange from pluvio stations
- Insufficient recording resolution of measurements (every 2 min)
- After adaption of recording resolution many fault alarms

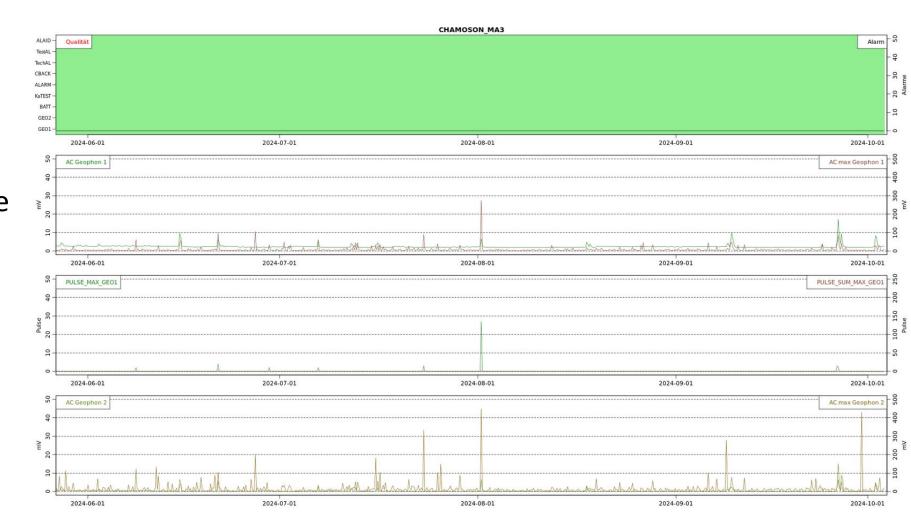
- cables to geophones monitored → technical alarms
- radio communication very simple and stable
- monitoring data to check function and sensitivity of geophone

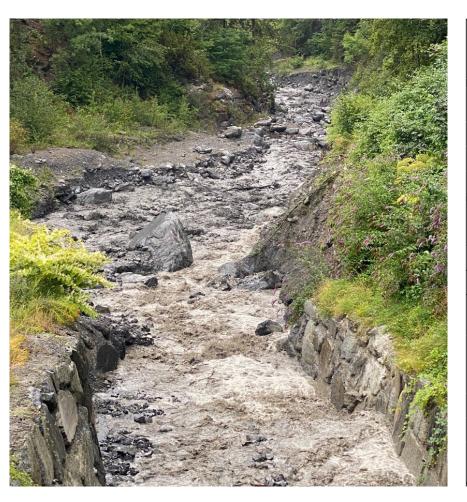
#### système d'alarme de laves torrentielles CHAMOSON VS

station CHAMOSON_MA2		Murgang-Detektion Torrent de Cry	AE 24 009	
propriétaire		Commune de Chamoso	n	
fournisseur	date d'installation	SensAlpin GmbH	24.04.2024	
coordonnées	altitude	582'028, 118'401	904

- Event with increased discharge but no debris flow on August 17, 2024
- After discussion with local observer addaption of trigger level:
  - vTrigger 200 mV
  - pulsSum 150
- →Only event 2 would now cause alarm!
- Further increase of trigger levels possible after more experiance

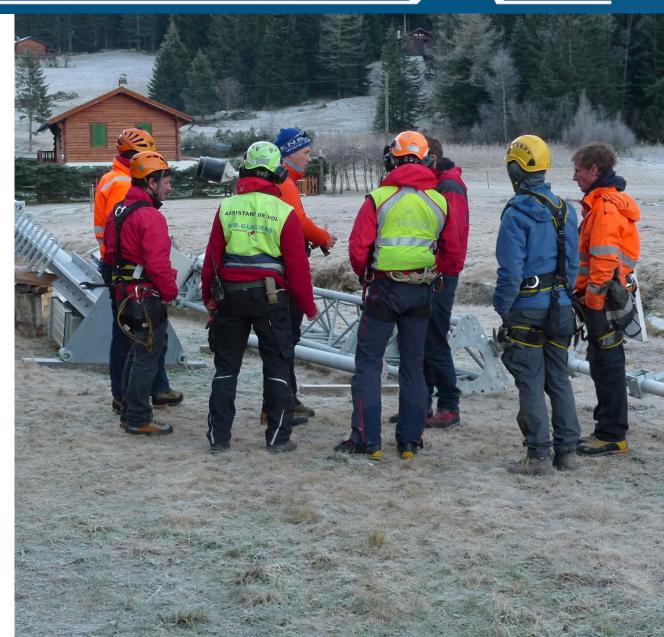
#### Example 3: Münster

- Debris flow alarm system to secure excavation work in basin
- Two detection stations
- One signal station with flashlight and siren
- Webcam to monitor retention basin
- Upper detection with 2 geophones
- Lower detection with 2 geophones and level sensor

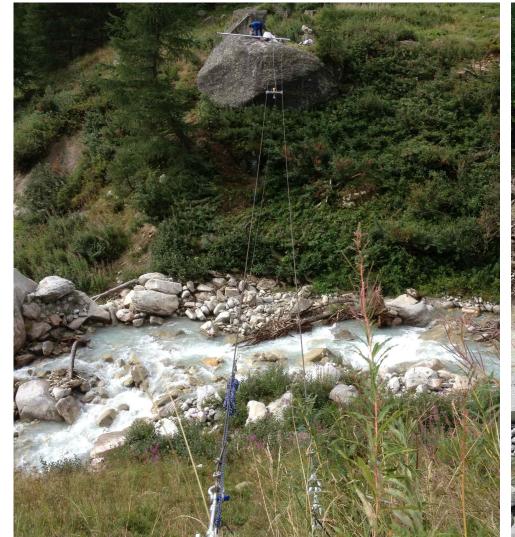
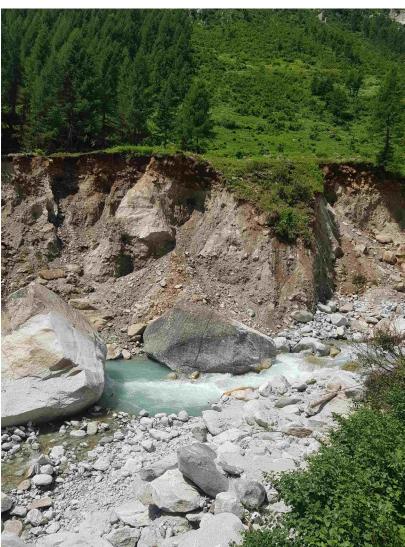
- Rock from lower detection collapsed
- Worst case scenario
- Station issued alarm
- Station continued operation after falling into stream
- Temporary backup was installed within two weeks

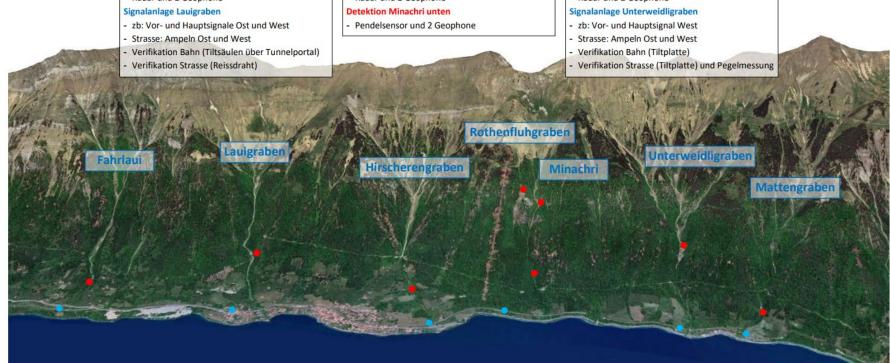
8 detection stations

6 signal stations with verification

35 traffic lights (road & railway)

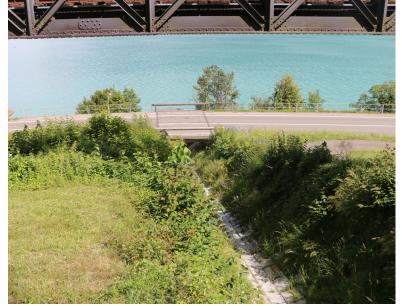
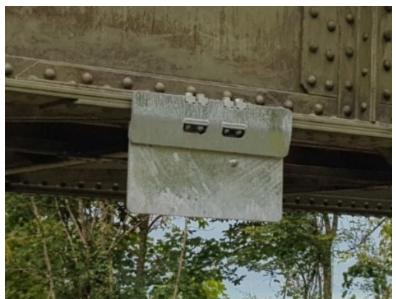
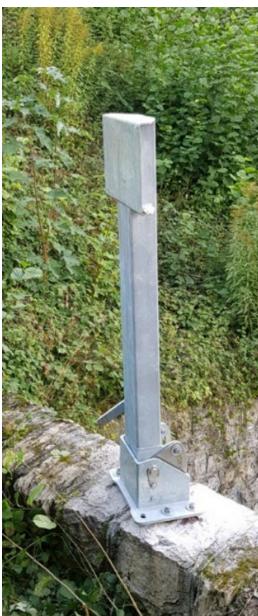
- Verification at bridges / beside railway by tilt sensors or rip cords to confirm runout
- Different alarm criteria for road and railway
- Interaction between different traffic lights
