# **GLOFCA PROJECT**

**«Reducing vulnerabilities of populations in the Central Asia region  
from glacier lake outburst floods in a changing climate»**

## **Report on task 9B:**

**Conducting field work at the dam and in the Adygene  
Lake area. Performing a set of geophysical measurements,  
drone surveys and GPS measurements of ground reference  
points**

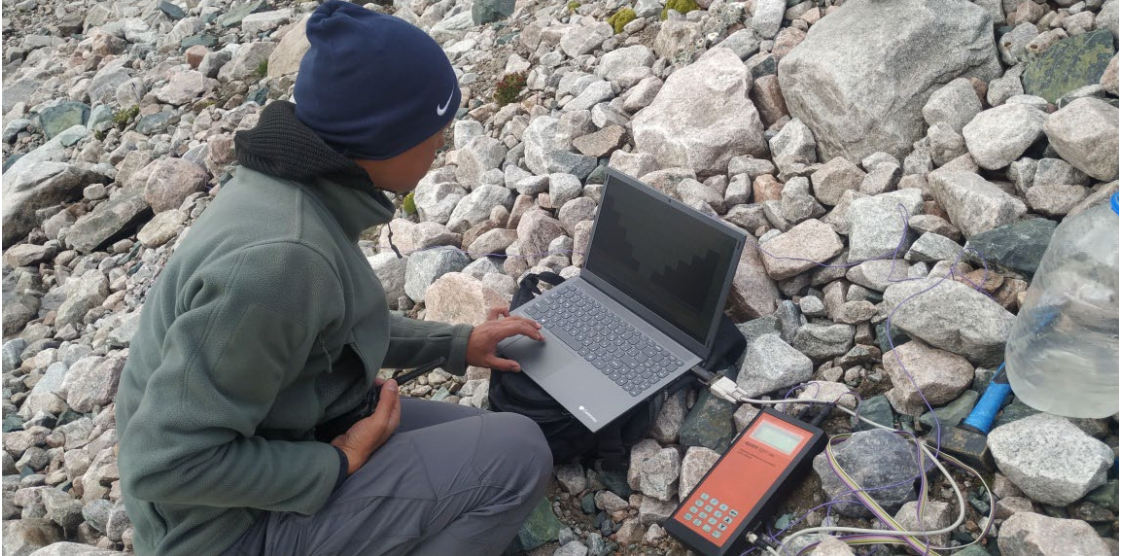
Fig. 3 Conducting electrotomographic measurements.

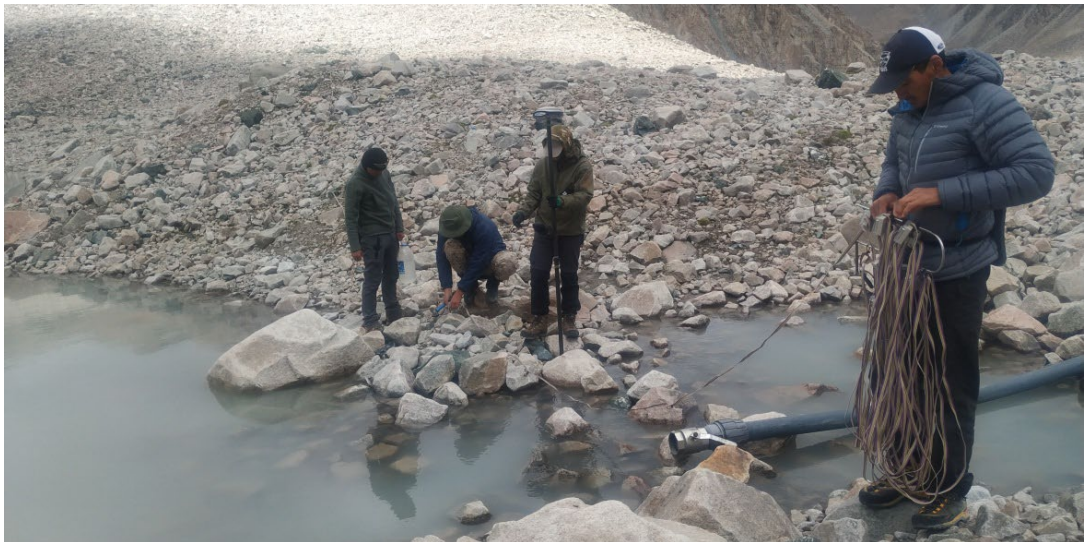
Fig. 4 Installation and connection of electrodes for electrotomographic measurements.

The measurements were carried out using the dipole-dipole method. The number of electrodes used is 20 pieces. The distance between the electrodes is 5 m.

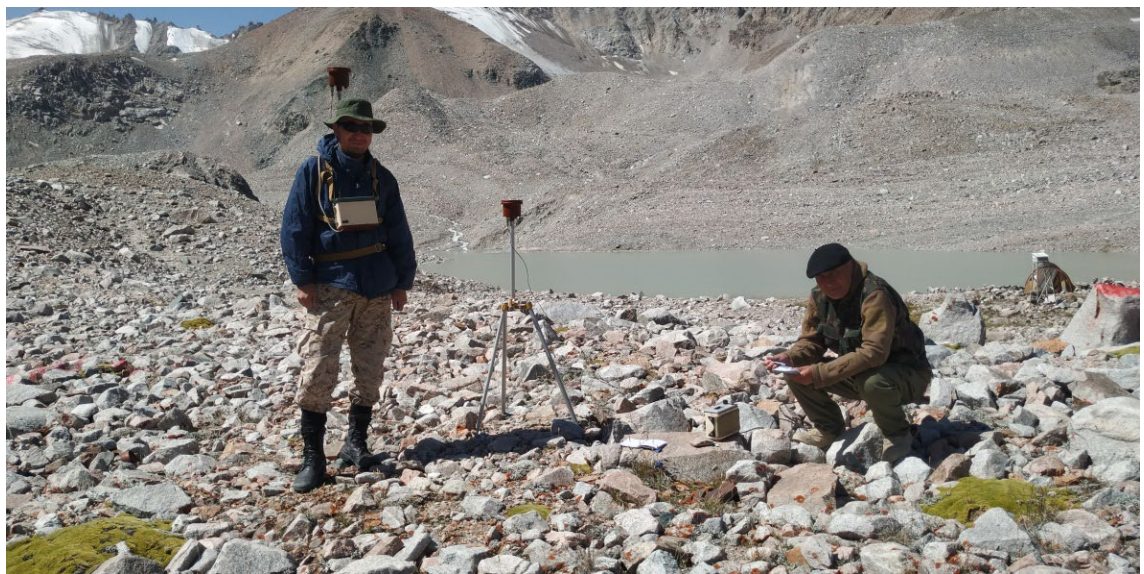
Fig. 10 Carrying out magnetometric measurements.

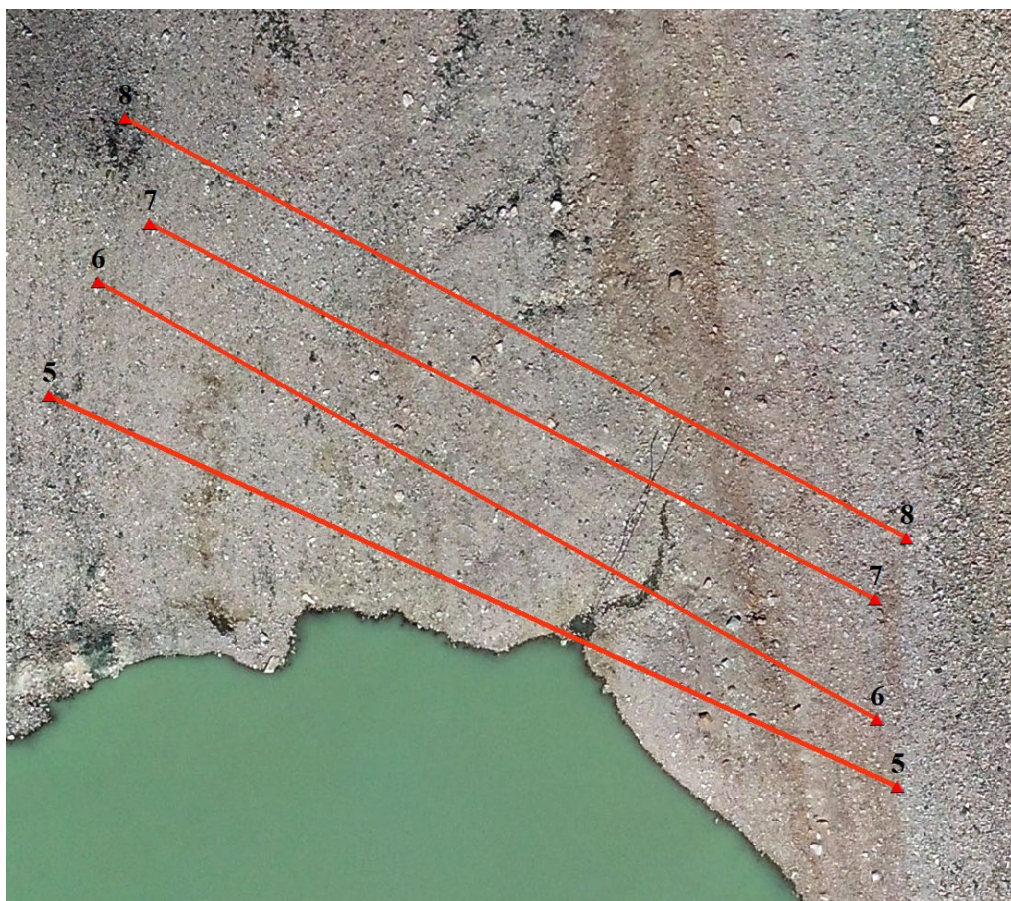
Fig.14 Plan of profiles of magnetometric measurements at the dam of Lake Prilodnikovoye Adygene.

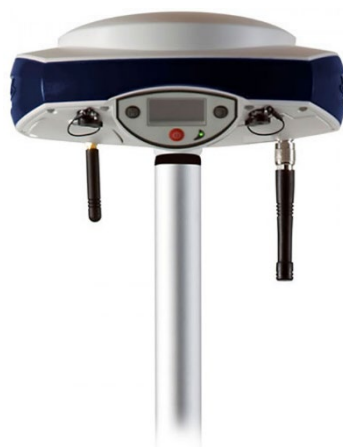
During the field survey, ground control points were established for subsequent geodetic measurements and aerial photography. The coordinates of these points were determined using a dual-frequency GNSS receiver ASHTECH PROMARK 800 with a high accuracy not exceeding 30 cm at a distance from one reference point to the next, ranging from 200 meters to one kilometer. This ensured uniform coverage of the surveyed area.

Fig.2 Dual frequency GNSS receiver ASHTECH PROMARK 800

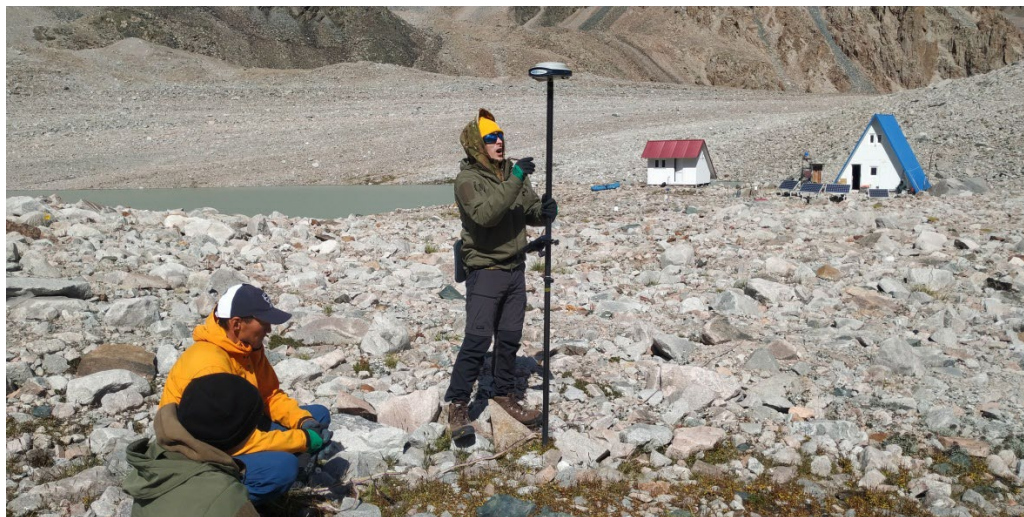
Fig.3 Measurement of ground point coordinates.

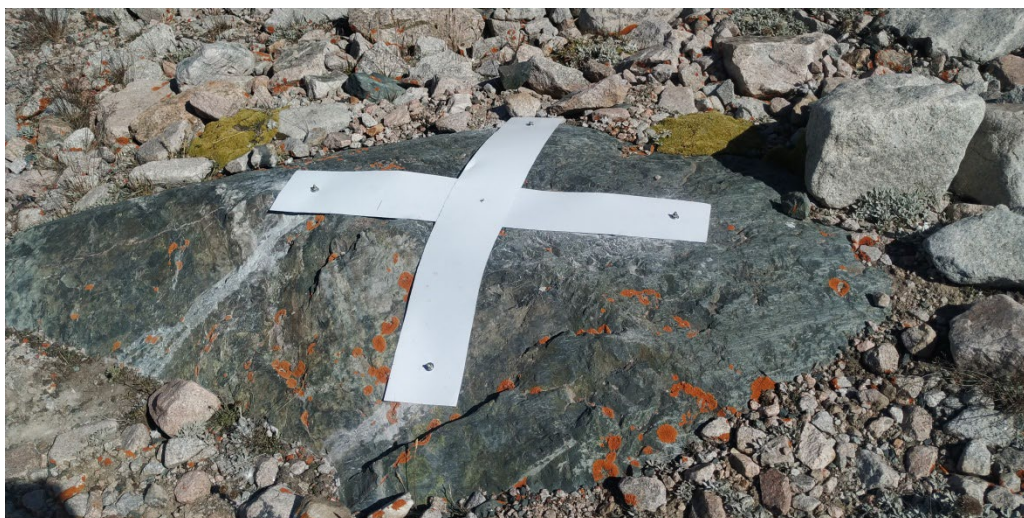
The ground control points were specially made of 0.6 mm thick galvanized sheets coated with an anti-corrosion layer and painted with white paint to ensure good visibility at their installation sites (Fig.4). Their shape in the form of a cross (cruciform shape) with the size of 120x120 cm provided effective recognition and georeferencing in further processing of aerial photography. The total number of installed ground points amounted to 11.

Fig.4 Ground reference with coordinates, for georeferencing of aerial survey results

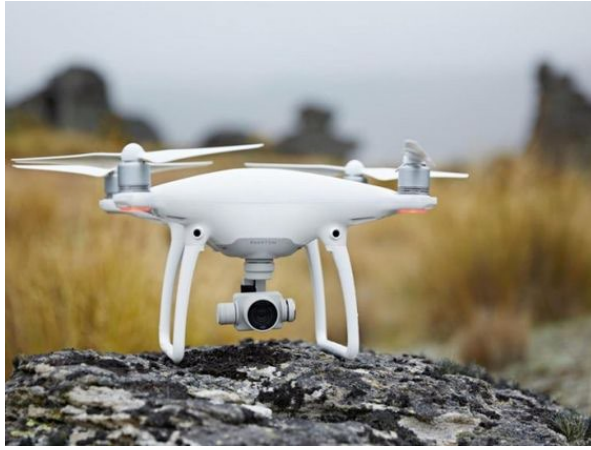
Aerial photography was conducted using a DJI Phantom 4 Pro V2.0 quadcopter. The survey was carried out at an altitude of 500 meters from the launch site, taking into account the complexity of the relief and scale of the glacier. These data became an important element of preliminary processing and further analysis of geoinformation data obtained from studies of permafrost-ice dams of high-mountain lakes Bolshoye Adygene and Priledniokovoe Adygene in the upper reaches of the Ala-Archa River basin in Alamudun district of Chui oblast of Kyrgyzstan.

Fig. 5 DJI Phantom 4 Pro V2.0 quadcopter
